2 February 2024

Thames Valley Surveying

70 Sturges Road, Wokingham, Berkshire, RG40 2HB
Inspection of defective lintels

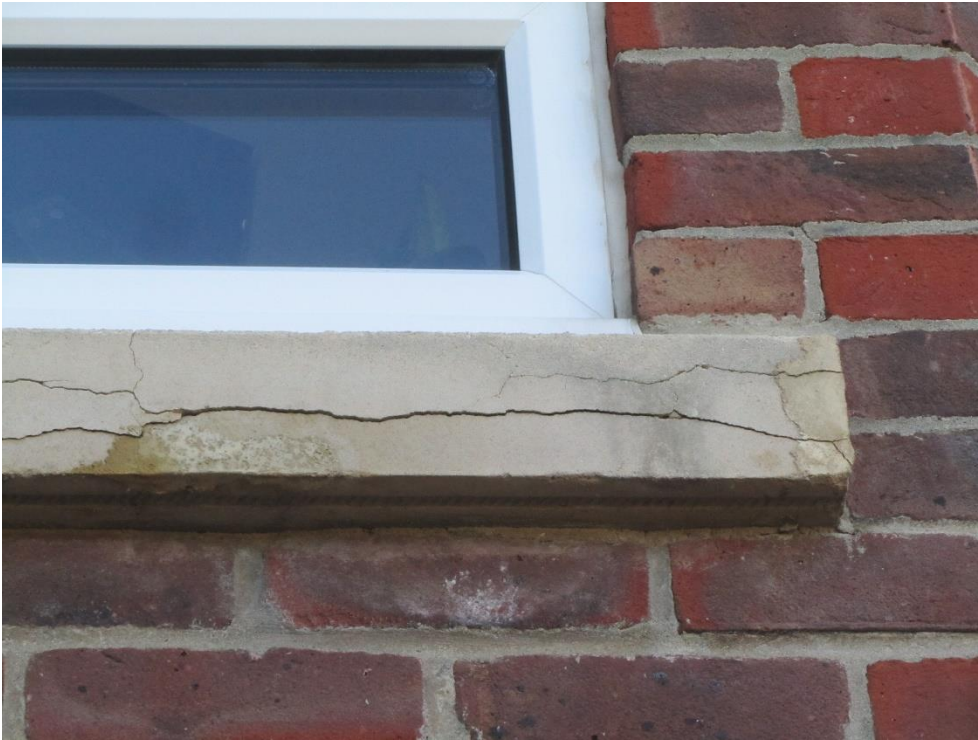
The structure of the building is comprised of an assumed masonry cavity wall, which will have the structural lintel spanned over the cavity. The stone heads and cills are purely an aesthetic feature these are not causing any current structural issues. The damage seen is due to a poor quality product, poor installation and a poor standard of remedial repairs,

Overall, the condition of the heads and cills were varied. The worst heads and cills had received historical plastic repairs, and in some cases, they had been decorated with an assumed non breathable masonry paint. The use of non-masonry paint to a repair on reconstituted stonework can cause water to become trapped and will ultimately blister the paint and cause cracking to the head and cills.

Photo 2 – View of a previously repaired and decorated cill that is now experiencing large cracking. Typical category 1.

Some of the Category 1 items are beyond repair and will require replacement.

We recommend that you consult with a reputable company that performs plastic repairs to reconstituted stonework, details of reputable contractors can be found from the Cast Stone Association.

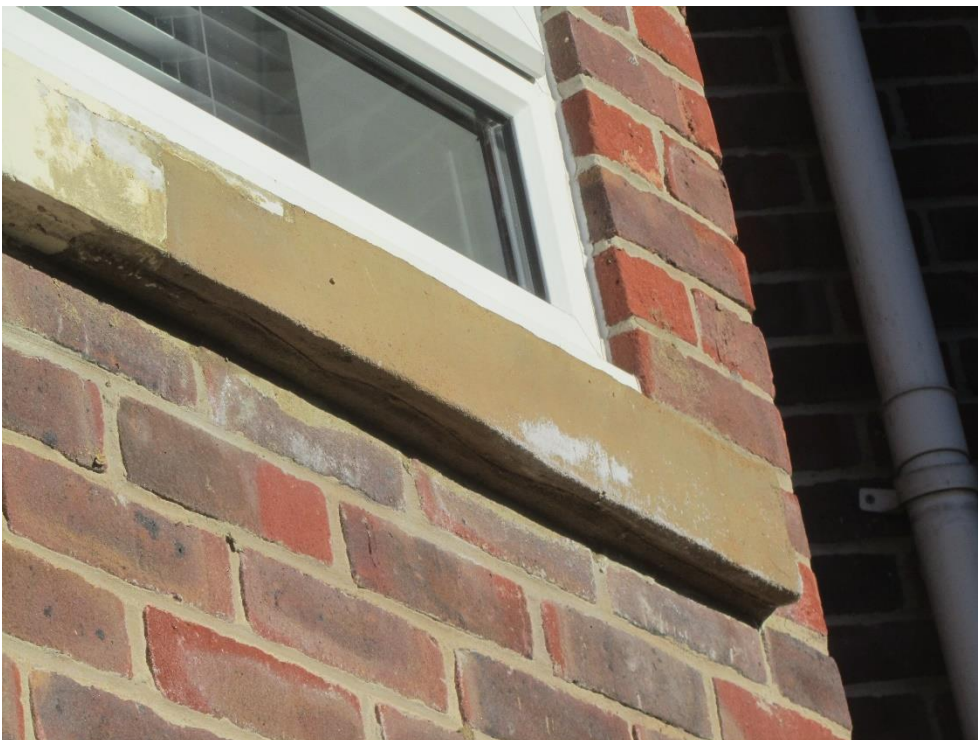
Photo 3 – Cill which has had an historic repair and decoration. This is typical of a category 2 as it has potential to worsen over time. It is also at first floor level.

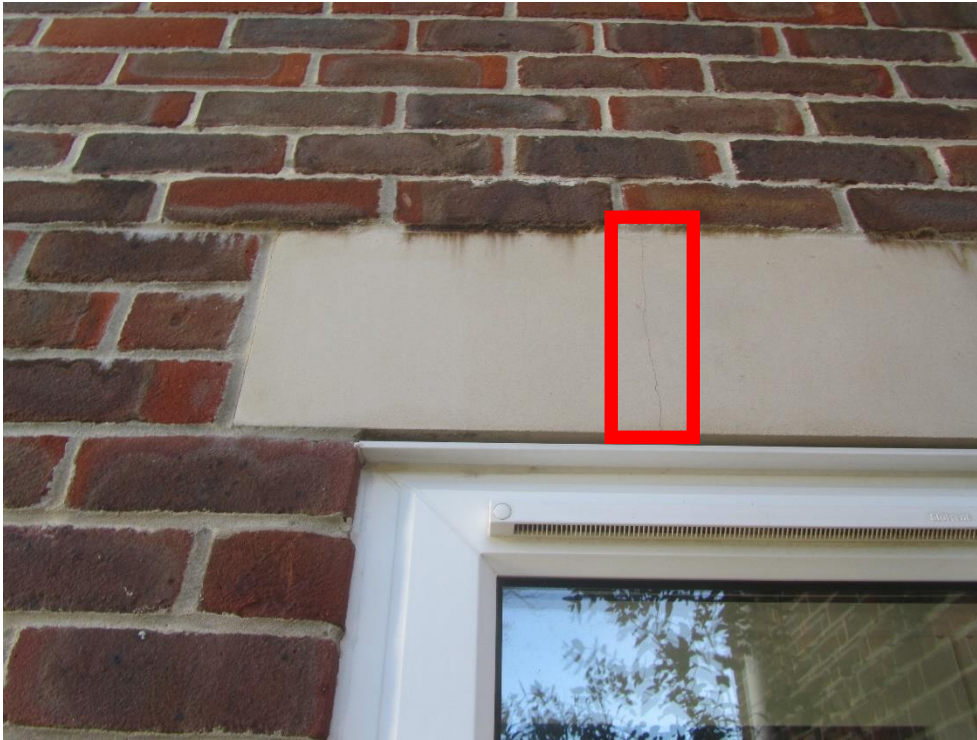
Photo 4 – Typical view of hairline cracking to head. Typical feature of a category 3.

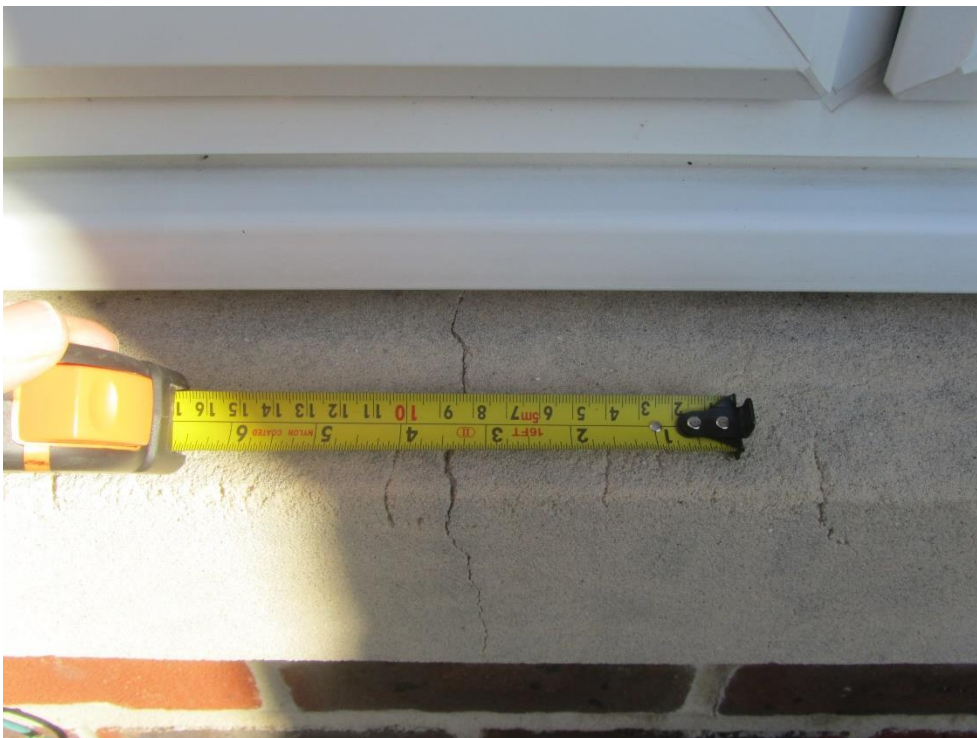
Photo 5 – View of cracking which has become wider than hairline cracking width.

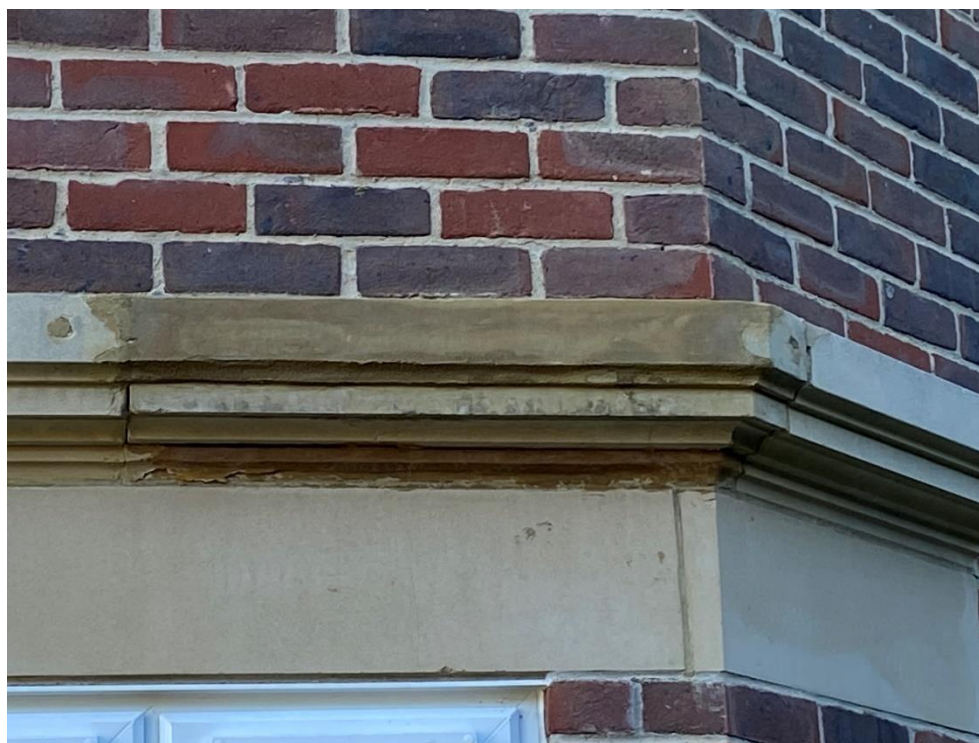
Photo 6 – View of poor repair to string course above window head to the rear elevation.

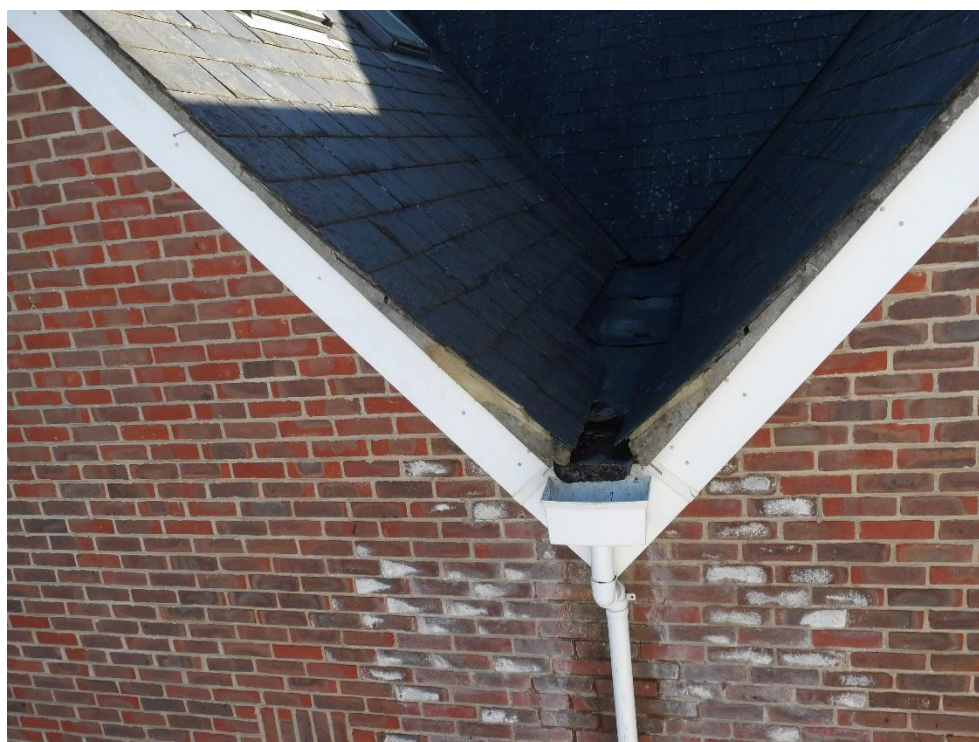
We inspected the hopper detail on both of the side elevations. Upon inspection of the property's rainwater goods, it has been noted that the hopper's dimensions appear to be relatively smaller compared to the expansive roof space it is intended to service. This is of particular concern due to the hopper's location in proximity to three steep roof valleys. These valleys, by their design, are likely to channel a significant volume of water towards the hopper, especially during heavy rainfall.

The configuration of these roof valleys in relation to the hopper presents a potential risk for rapid water accumulation. The hopper, given its current capacity, may not be able to adequately handle the influx of water, leading it to overflow. This could result in water saturation and the subsequent efflorescence staining to the external brickwork. Additionally, any water that seeps into the brickwork and cracks can worsen with freeze thaw weather, as the water inside the brickwork freezes it causes expansion to any existing cracks, and to the brickwork itself.

Furthermore, there may be problems with the functionality of the hopper itself, it may be possible that the hopper is leaking or could be blocked. The efficiency of the hopper is also contingent on the adequate channelling of water by the surrounding lead work. If the lead work is improperly installed, or has deteriorated, it could lead to significant water misdirection.

Photo 7 – View of hopper and downpipe feature to the side elevation. With staining to the exterior of the property.

To address the insufficient capacity of the hopper relative to the expansive roof space and its proximity to three steep roof valleys, an upgrade to a larger hopper is recommended. This would more effectively manage the high volume of water expected during heavy rainfall.

Additionally, a full and thorough inspection and necessary repair or replacement of the current hopper is advised to resolve any issues of leaking or blockages. Ensuring regular maintenance will help in preventing similar problems in the future.

The lead work surrounding the hopper warrants and potential remediation. Any improper installation or deterioration that impairs the effective channelling of water needs to be corrected.

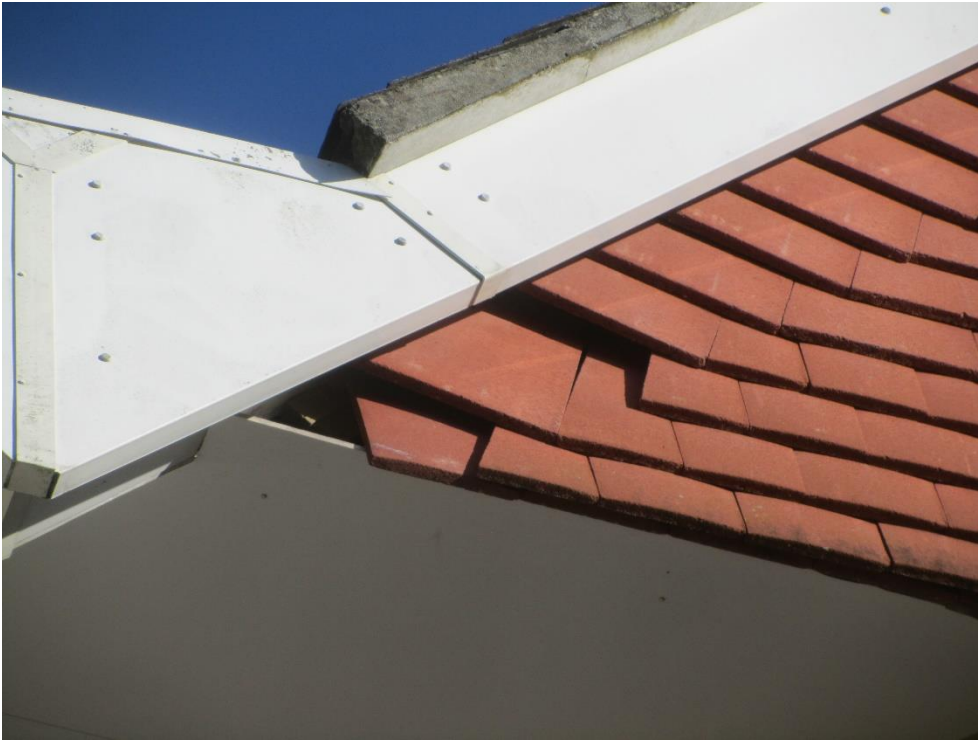
To the top gables of this property, there is a tile hanging featuring, which is comprised of assumed red sand faced tiles. We noticed that some of the tiles are starting to move and slip.

These slipped tiles are situated above door openings and the front and rear gardens, so these pose a potential health and safety risk to the residents. Furthermore, this may encourage vermin, or other animals to nest within the voids that the tile slipping has created.

The observed looseness of the tiles not only presents a health and safety hazard, potentially posing a risk of falling debris, but also invites the risk of wildlife intrusion. The gaps left by these tiles could become conducive to roosting and nesting by birds and other animals.

Photo 8 – View of slipped tile hanging to the front elevation gable.

We recommend that the reinstatement of the dislodged tiles should be reinstated and undertaken by a certified and reputable roofing specialist. This recommendation stems from a detailed assessment of the tiles' current condition and their location.

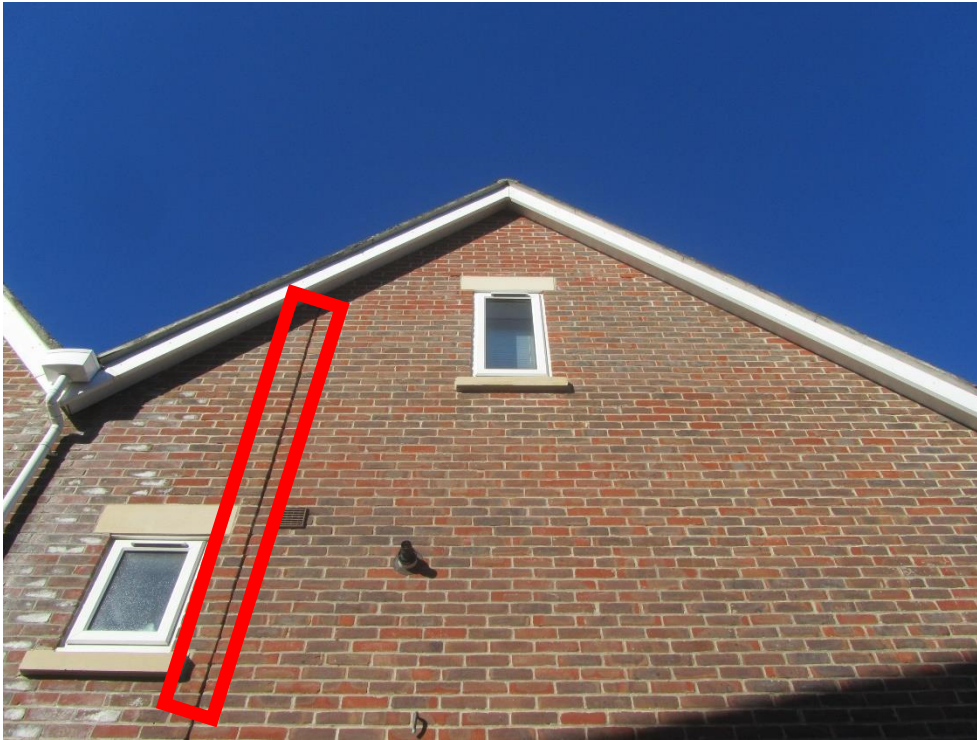
During our inspection it was observed that the expansion joint did not have filling or sealant present.

These joints are designed to absorb movement caused by thermal expansion, shifts in the soil, and other environmental factors. Without proper filling, expansion joints are vulnerable to water infiltration, leading to potential water damage and corrosion within the structure. Additionally, debris can accumulate in these empty spaces, hindering the joint's functionality and possibly causing undue stress on building materials. This neglect can accelerate wear and tear on the structure, compromise its integrity, and lead to costly repairs. Moreover, unsealed joints can result in decreased energy efficiency in buildings, as they allow for unwanted air infiltration, affecting indoor climate control.

Photo 9 – View of expansion joint on the side elevation.

Lastly, we recommend that you consult a reputable contractor for the installation of appropriate filler material for the expansion joint on the side elevation. Given the critical role of expansion joints in accommodating structural movements due to thermal changes and other environmental influences, expert guidance is essential

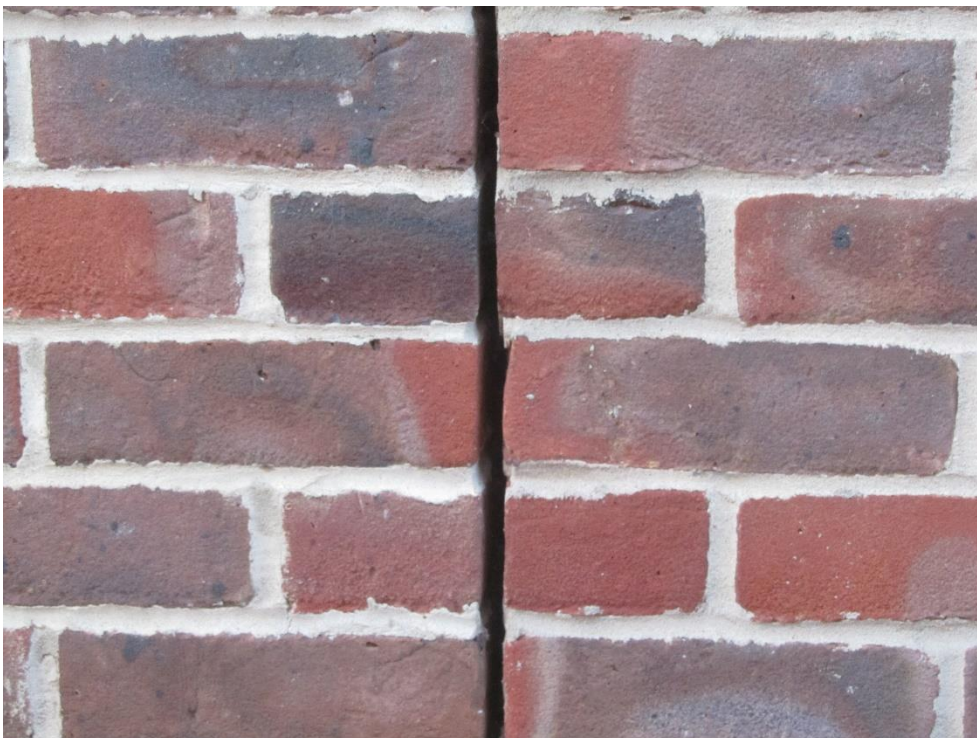
Photo 10 – View up close of expansion joint, showing no filling inside the joint.
